① 14 Rept. no. MR 1471
NRL Memorandum Report 1471

**FATIGUE CRACK PROPAGATION IN
HIGH STRENGTH 4340 STEEL,**

⑩ by E. P. DAHLBERG
AND
D. B. LYTLE

METALLURGY DIVISION

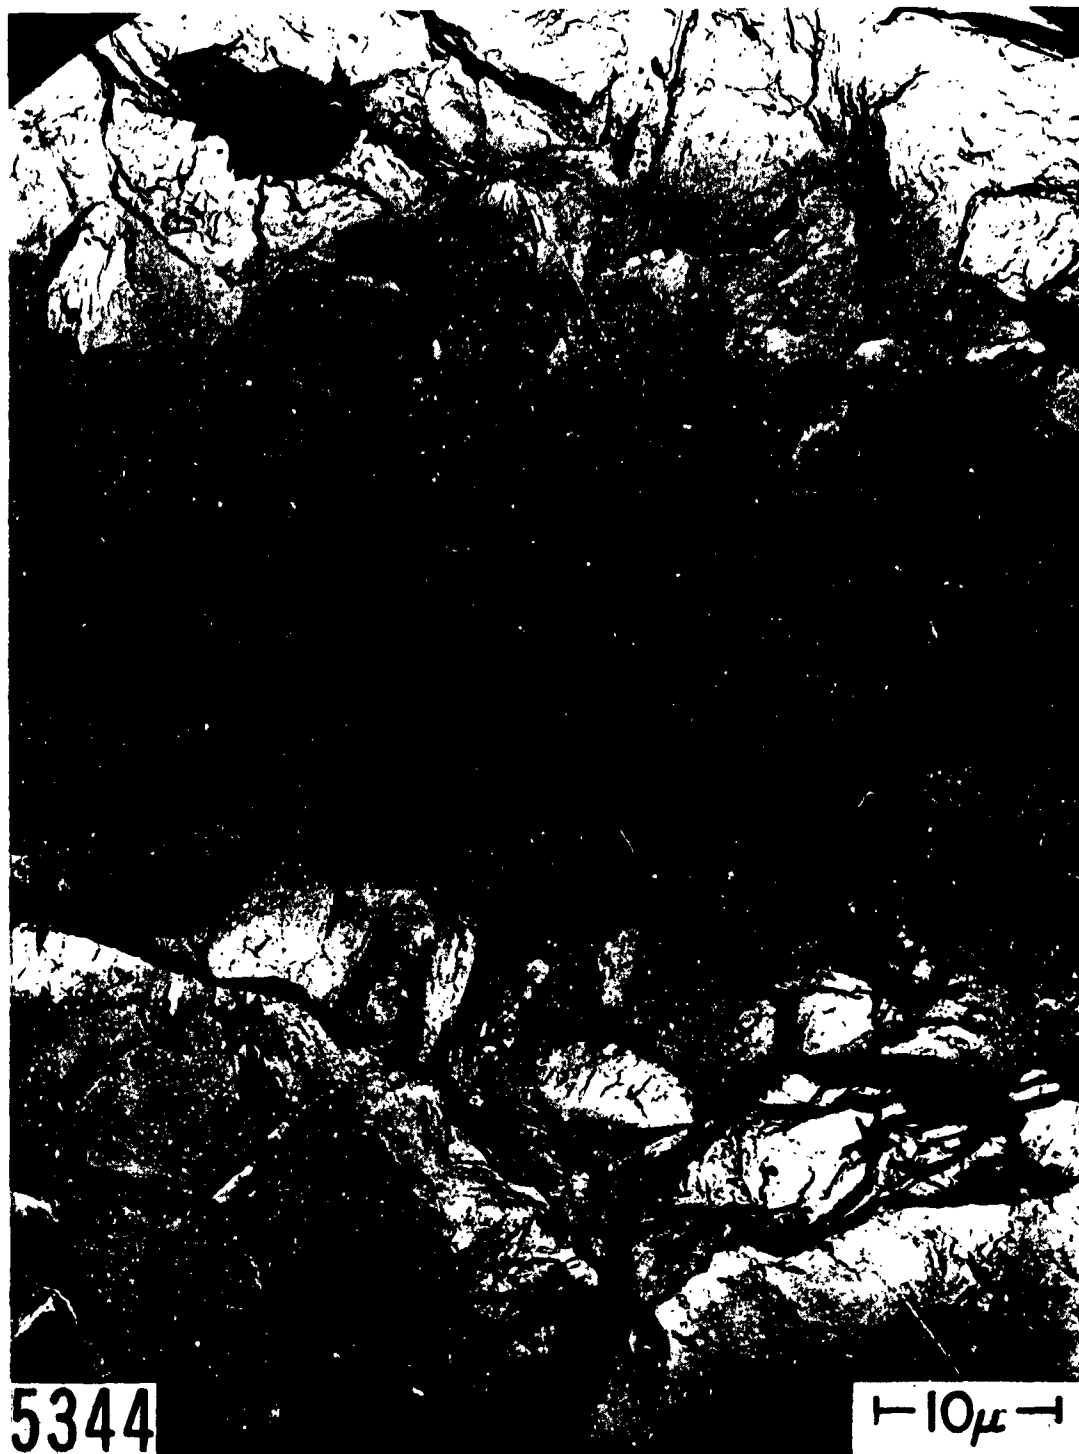
Figure 3 - Intergranular fracture observed in the "flame" shaped region of specimen AT-42. (a on Figure 2) Mag. 3000X.

Figure 3 shows the fracture topography which developed in the flame shaped region at the very beginning of crack growth in specimen AT-42. It is distinctly intergranular. The fine detail on the grain facets, observed by stereographic viewing, consists entirely of ridges raised above the general

level of each grain. These tear ridges may result from a limited amount of ductility which accompanies the final stage of grain boundary separation. The details of tear ridge formation have been described by Beachem (2). The structure developed between the "flame" region and the area of fast fracture is shown in Figure 4. Although fatigue striations are not clearly resolved in this fractograph, the transgranular appearance and network of secondary cracking are characteristic of mechanical fatigue crack propagation in this material (3). The large arrow indicates the macroscopic direction of crack growth. Figure 5 shows the structure which developed in the fast fracture region. The fracture results from the coalescence of voids nucleating in front of the growing crack. The large dimples (arrows) may possibly be associated with grain boundary separation and subsequent deformation.

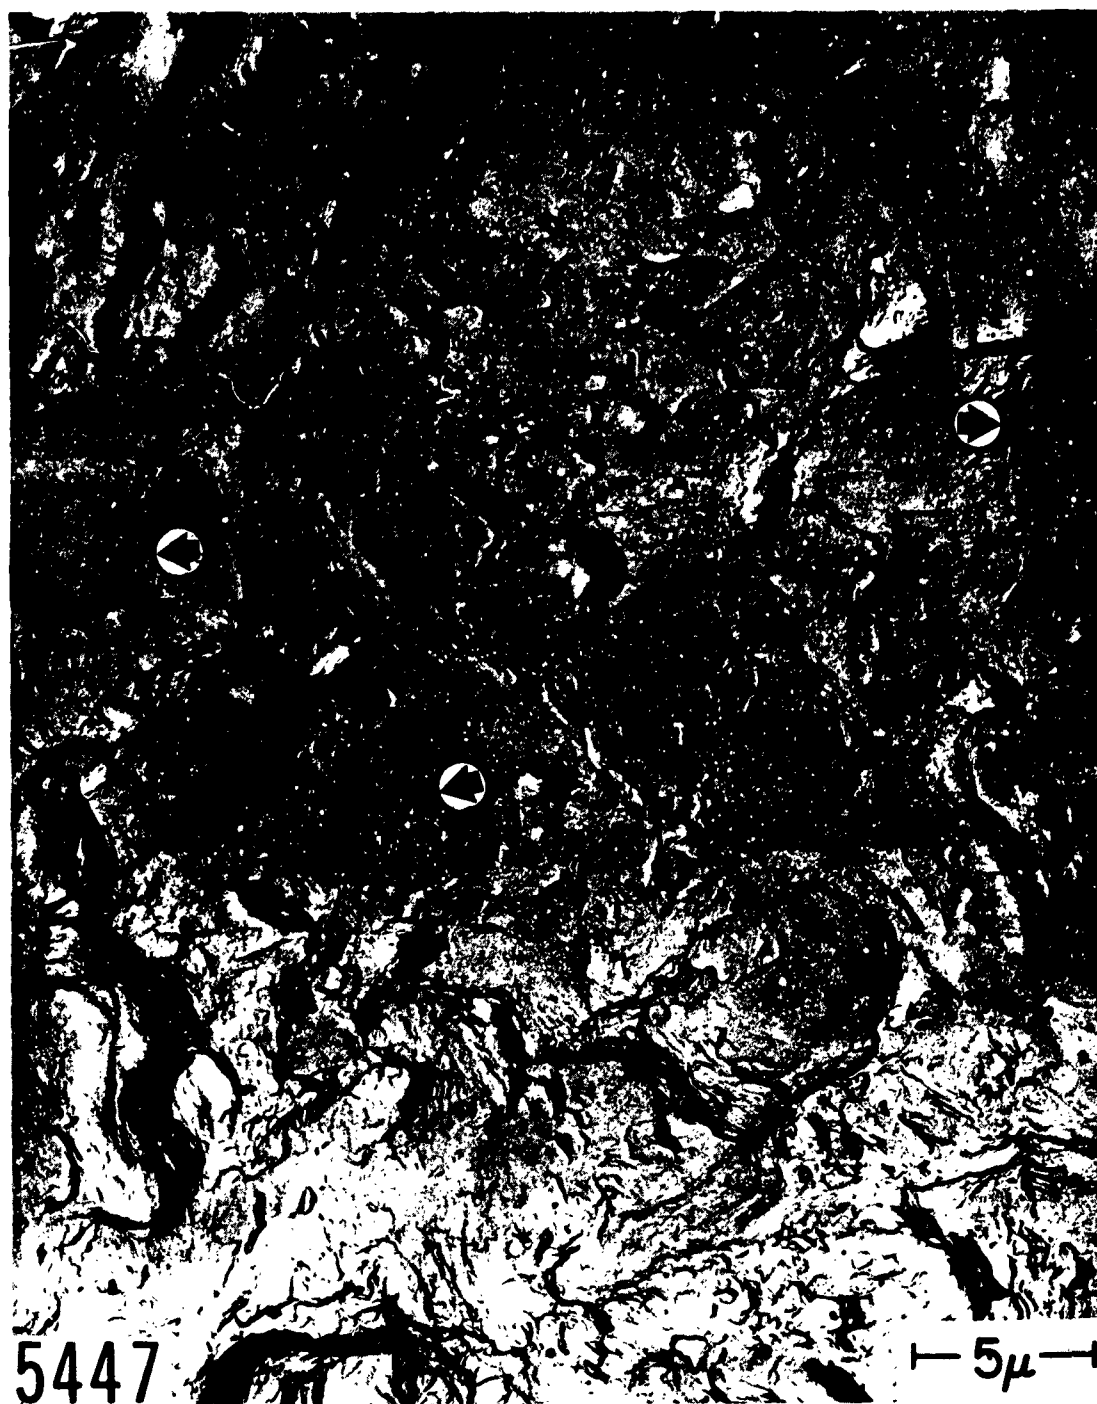
Figure 8 - Region of transgranular fatigue in specimen AT-50 (dry environment, 5/3 load fluctuation) showing patches of parallel fatigue striations. Mag. 6000X.

Figure 8 shows the fracture topography which developed approximately 0.60" from the tip of the fatigue pre-crack in specimen AT-46 which was tested with a 5/3 maximum-to-minimum load ratio in the dry atmosphere. The observed fatigue striations were not continuous over the entire surface but occurred in isolated patches (arrows).

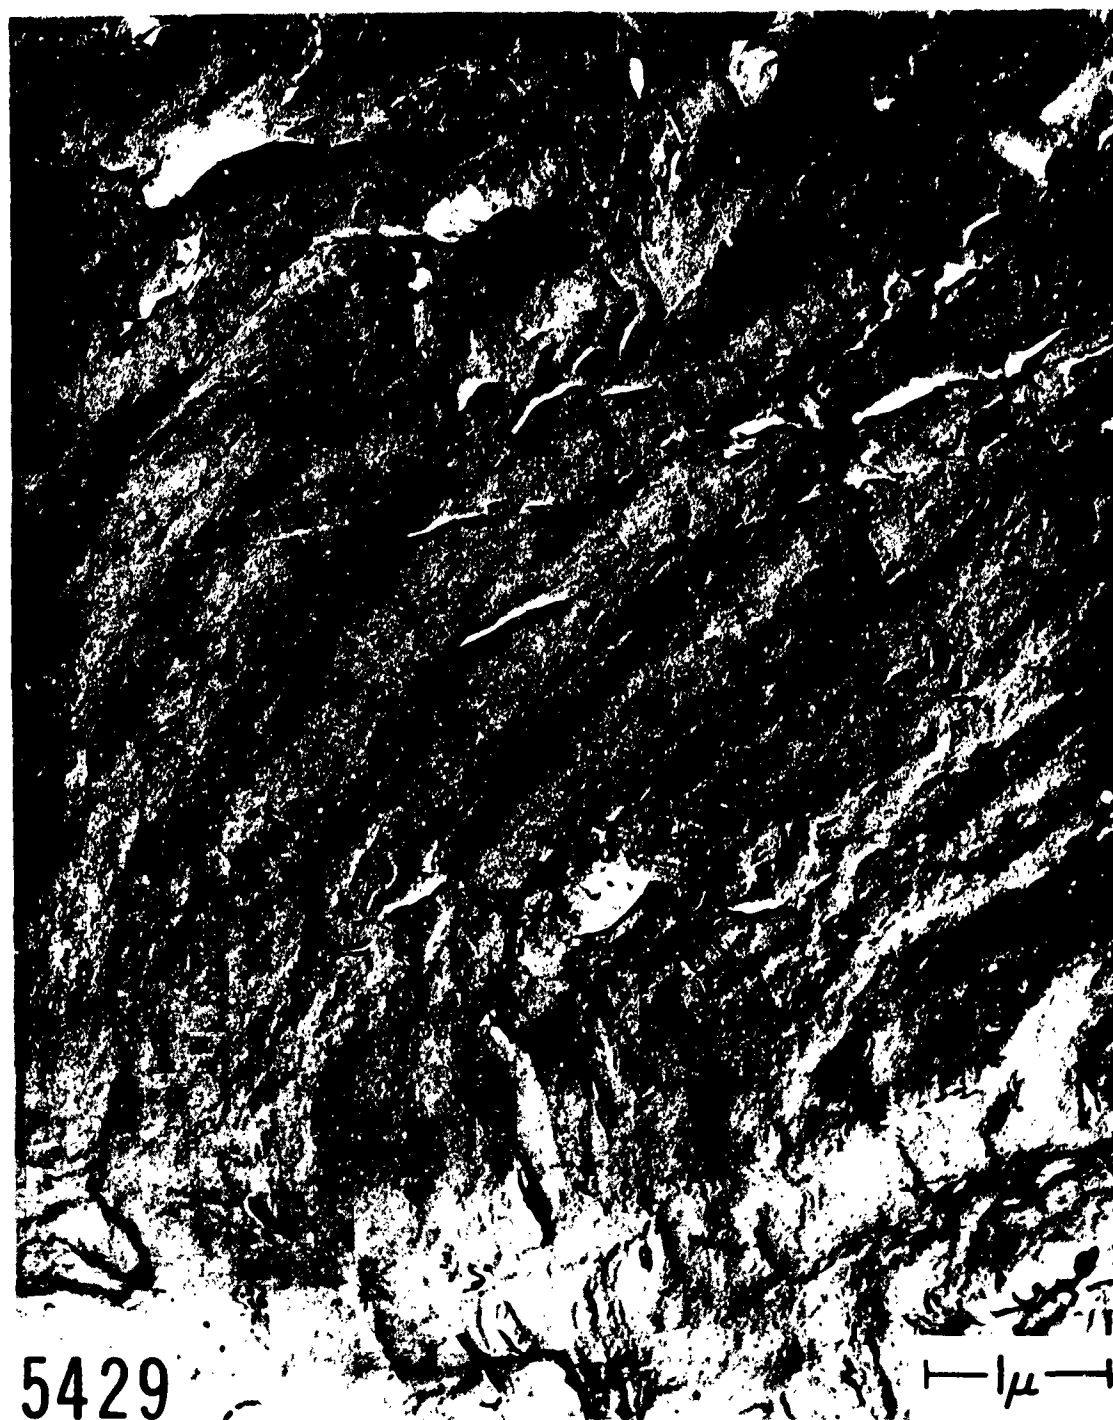
Figure 10 - Patch of parallel fatigue striations located on the surface of specimen AT-45 at a depth corresponding to a stress intensity of 46 KSI $\sqrt{\text{INCH}}$. Mag. 30,000X.

Fatigue striation spacings were measured at various crack depths on specimen AT-45 which was tested in dry air at a 5/1 load fluctuation ratio. Figure 9 shows a comparison of the observed crack growth rates and the striation spacing measurements. The maximum, minimum, and average striation spacing values are plotted together with the observed crack growth rate data. The close agreement of the two sets of data indicates that each striation results from a single stress cycle. Figure 10 shows several striations located at a depth corresponding to a stress intensity value of 46 KSI- $\sqrt{\text{INCH}}$.
